Part E—Description of the Charter School Facilities and Assurances*

*Facility Master Plan/ Ed Spec
2017 - 2022
October 26, 2017*

This assessment report addresses concerns with cracking and delaminating of existing stucco, flashing details, and documented locations of leakage. After a summary of recommendations, existing construction issues are detailed. The second part of the report offers recommendations for remediation. Photos, referenced throughout, are at the end of this document.

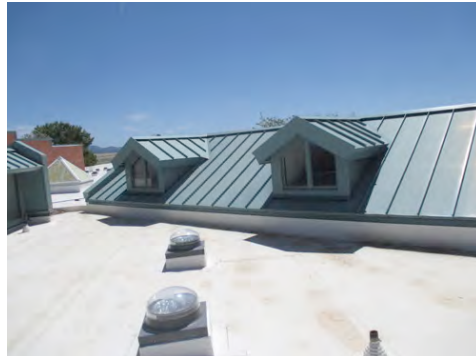
Leakage was reported in Entry Hallway at dormer windows on northwest side. Existing construction is metal skin / roof system over wood frame. No underlayment is evident. Wood is exposed and visible in some areas. Surface joints between metal pieces were unsealed. (PHOTOS #14 THRU #19)

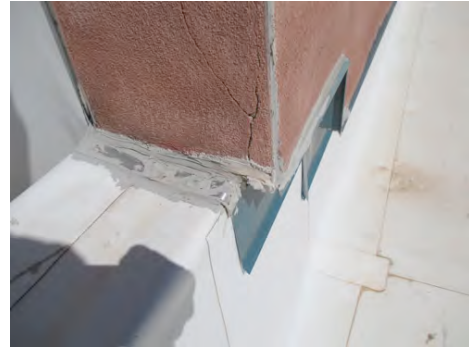
Roof to wall terminations, where parapets or low walls meet adjacent perpendicular walls, are poorly detailed with surface or butt terminations, no flashing / counterflashing, and no saddle flashing at the substrate.

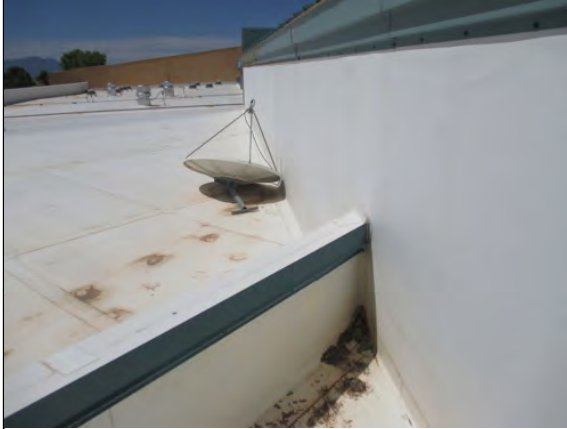
PHOTO #25-Roof/wall area above leak in hallway

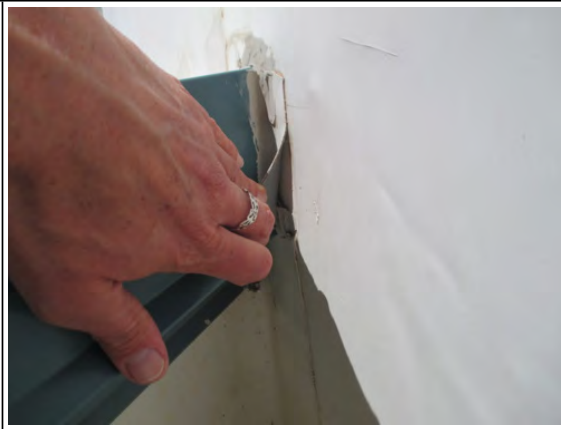
PHOTO #26- Roof membrane corner at parapet wall poorly sealed

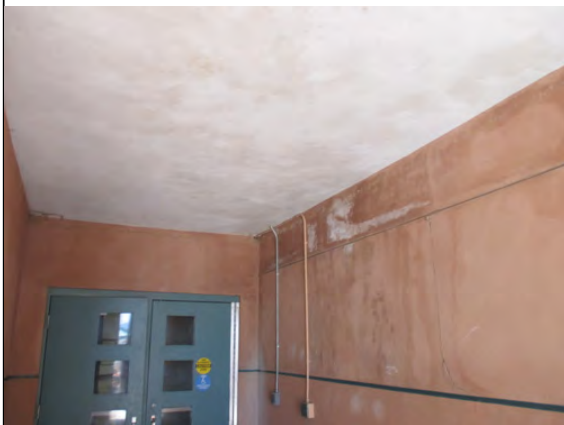
PHOTO #27- Hallway; evidence of leak at stucco

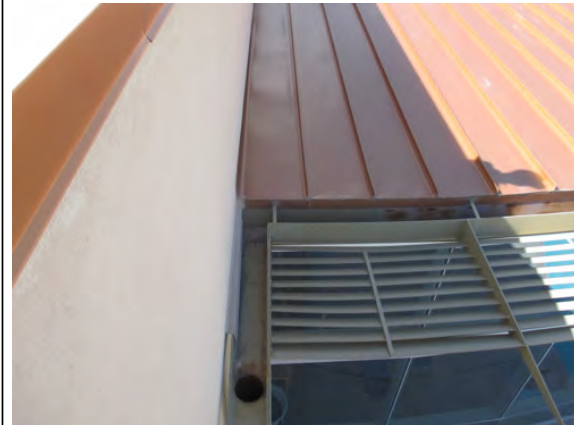
PHOTO #28- Entry curtainwall from above at corner where leak was reported

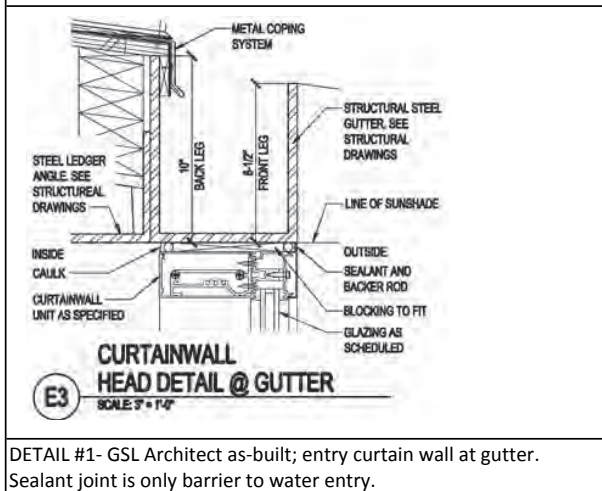
DETAIL #1- GSL Architect as-built; entry curtain wall at gutter. Sealant joint is only barrier to water entry.

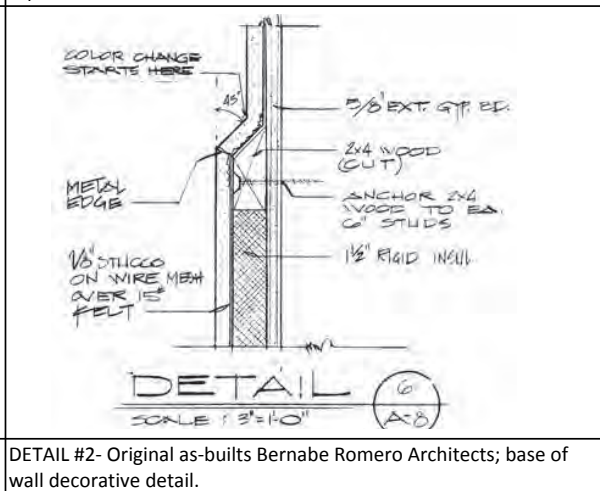
DETAIL #2- Original as-builts Bernabe Romero Architects; base of wall decorative detail.
