Part E—Description of the Charter School Facilities and Assurances*

*Facility Master Plan/ Ed Spec
2017 - 2022
October 26, 2017*

This assessment report addresses concerns with cracking and delaminating of existing stucco, flashing details, and documented locations of leakage. After a summary of recommendations, existing construction issues are detailed. The second part of the report offers recommendations for remediation. Photos, referenced throughout, are at the end of this document.

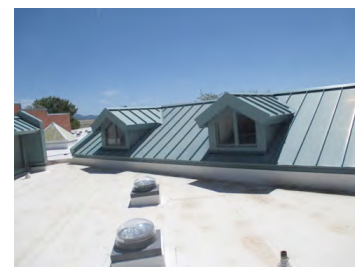
Leakage was reported in the Entry Hallway at dormer windows on northwest side. Existing construction is metal skin / roof system over wood frame. No underlayment is evident. Wood is exposed and visible

in some areas. (PHOTOS #14 THRU #19)

Leakage was reported in Entry Hallway at dormer windows on northwest side. Existing construction is metal skin / roof system over wood frame. No underlayment is evident. Wood is exposed and visible in some areas. Surface joints between metal pieces were unsealed. (PHOTOS #14 THRU #19)

At cast-in-place concrete fin wall, remove all existing 'sky-facing' stucco at roof termination to concrete. Clean and apply new sealant. Consider counterflashing set into 1.5 inch deep kerf cut into concrete and filled with sealant before installing flashing; counterflashing to cover roofing termination at concrete. (PHOTO #14)
